WINTER 2016/2017  
Clubhouse Putting Green Data Collection  
Report  
Soil & Water Consulting

Jumping Brook Country Club

Course Name: Jumping Brook Country Club

Date of Visit: December 31, 2016

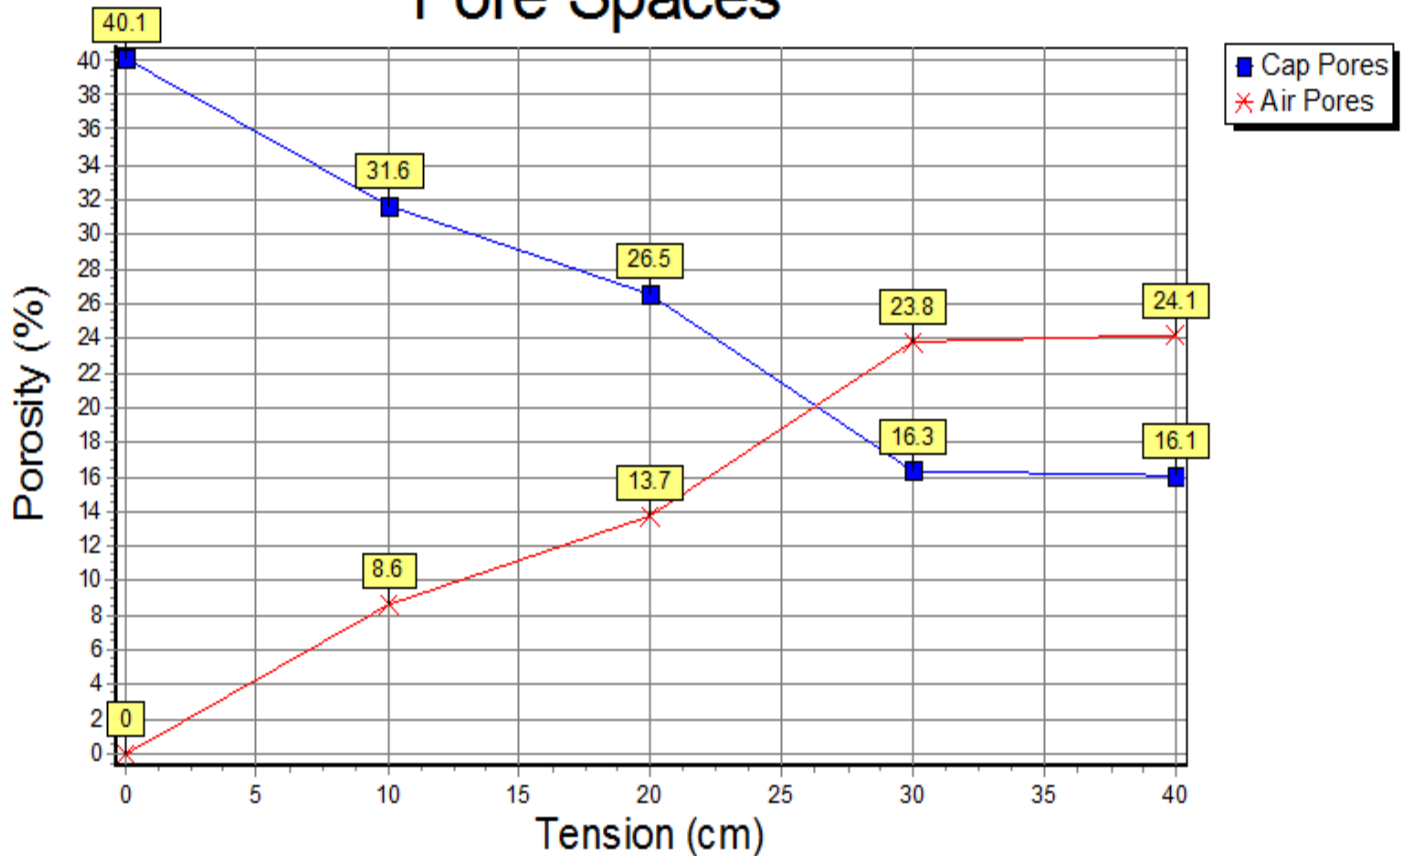
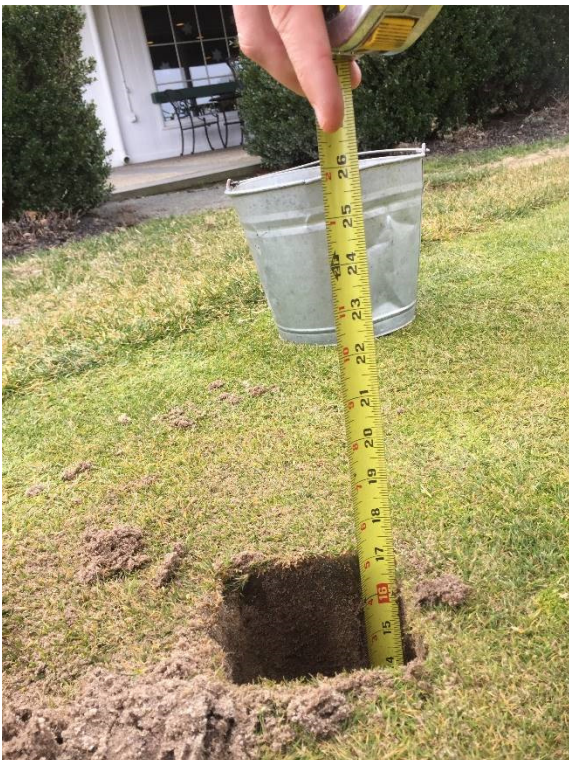
## Pore Spaces

The main thing to learn from these tests and the attached pictures is that the depth of the sand-mix is the issue. The mix used originally to build the green may be a 90/10 sand/peat mix. That by itself is ok. The testing shows us that this particular mix should be 10-11" deep to function correctly with regards to drainage and, in this case-more importantly- draw water up to the roots. This green has spots that are 17-20" deep! With that situation you will always have difficulty keeping water in the root zone. It drains too well and too fast, in other words. Also, because the clubhouse PG is so unlike the greens on the golf course it makes it difficult to manage. The reality is that you should aerify, topdress, water and fertilize this green completely different than the others. It requires more organic material, more amendments and more fertility. Irrigation is important and fixing the spacing will be helpful. The amount you irrigate this green with is weather dependent of course, but also may need to be a less amount of time than you are currently doing until you can build up organic material in the soil profile.

I would like to follow up in the Spring with regular soil testing to determine a path for proper fertility of the Clubhouse PG.
