WINTER 2016/2017  
Clubhouse Putting Green Data Collection  
Report  
Soil & Water Consulting

Jumping Brook Country Club

Course Name: Jumping Brook Country Club

Date of Visit: December 31, 2016

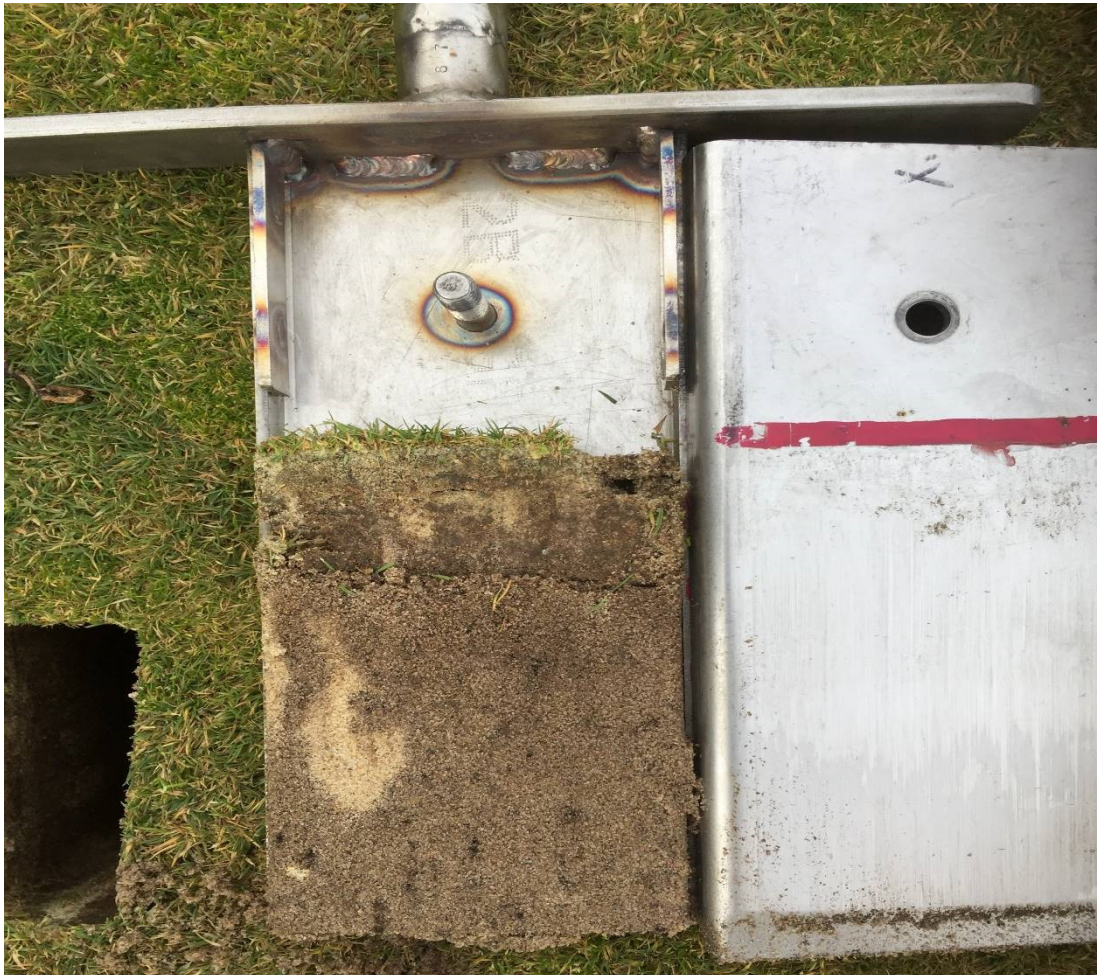
The main thing to learn from these tests and the attached pictures is that the depth of the sand-mix is the issue. The mix used originally to build the green may be a 90/10 sand/peat mix. That by itself is ok. The testing shows us that this particular mix should be 10-11" deep to function correctly with regards to drainage and, in this case-more importantly- draw water up to the roots. This green has spots that are 17-20" deep! With that situation you will always have difficulty keeping water in the root zone. It drains too well and too fast, in other words. Also, because the clubhouse PG is so unlike the greens on the golf course it makes it difficult to manage. The reality is that you should aerify, topdress, water and fertilize this green completely different than the others. It requires more organic material, more amendments and more fertility. Irrigation is important and fixing the spacing will be helpful. The amount you irrigate this green with is weather dependent of course, but also may need to be a less amount of time than you are currently doing until you can build up organic material in the soil profile.

I would like to follow up in the Spring with regular soil testing to determine a path for proper fertility of the Clubhouse PG.
